DW3 Models

P42H401, P40H4011, P40T501, A and Non A
 P50H401, P50H4011, P50T501, A and Non A
 P55H401, P55H4011, P55T551
 P60X901

2007 PDP

50" 55" and 60" DW3 Chassis

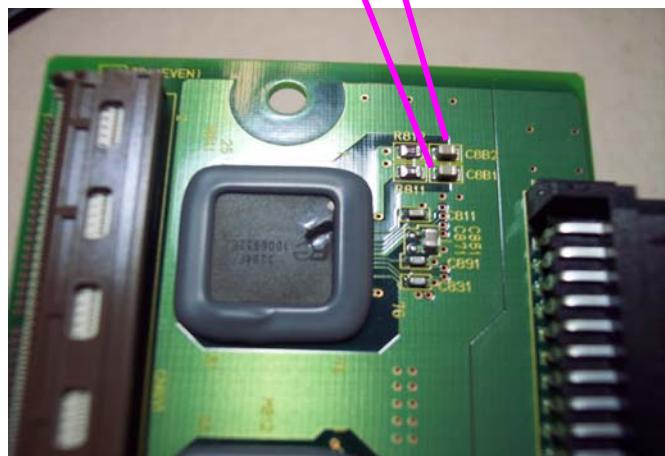
Small caps that will show shorted IF a buffer IC is shorted, regardless of having a blown up marking or not.

Each IC will have two of these small SMD caps on its Vcc line to ground.

Sometimes there will be some blown up holes or markings, however this may not be evident every time.

It is always recommended that you TEST with an ohmimeter all IC Vcc small SMD caps for shorts, if you find any of them shorted-then SDR PWB is defective, replace it.

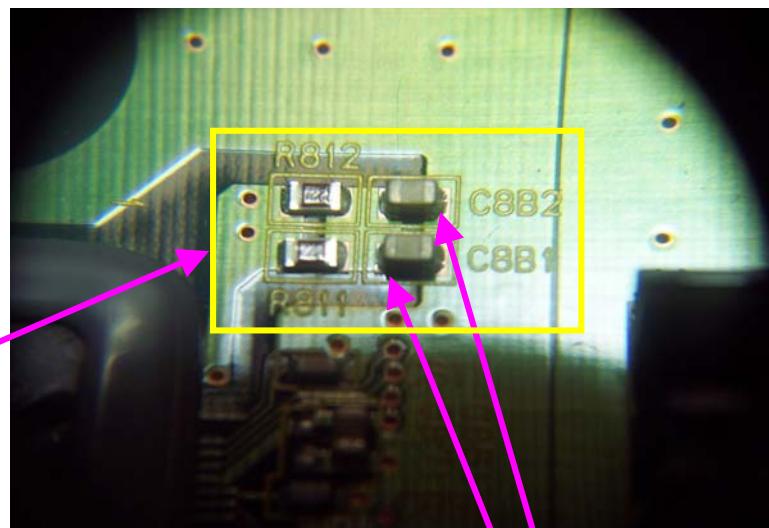
Each buffer IC has a set of two of these SMD capacitors, from Ics Vcc to ground.

Using a ohmimeter in continuity test-looking for shorts - or simply checking resistance, test across each one of these SMD ceramic capacitors. If any of them is found shorted- the SDR PWB must be replaced.

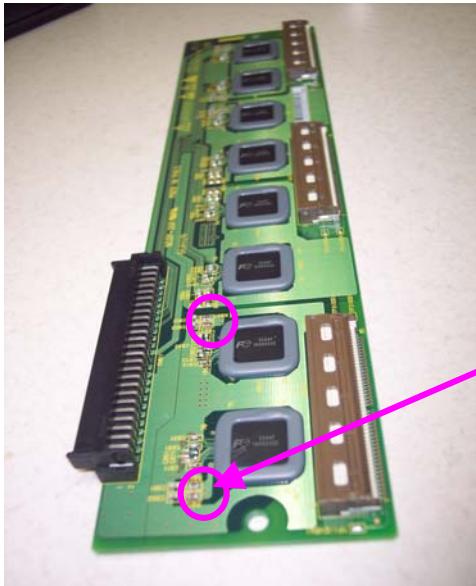
Any time you are dealing with a Dead Unit or- a unit that will not power up, or, that it will come on but the TV will protect itself and kill the Va and Vs. Check/confirm the SDR PWBs do not have any shorted Ics on them.
